Appendix F. Baseline Measurements

This document presents details on the baseline measurements undertaken for the Melbourne Metro. The types of measurements that have been undertaken and their corresponding sections in this appendix are described below:

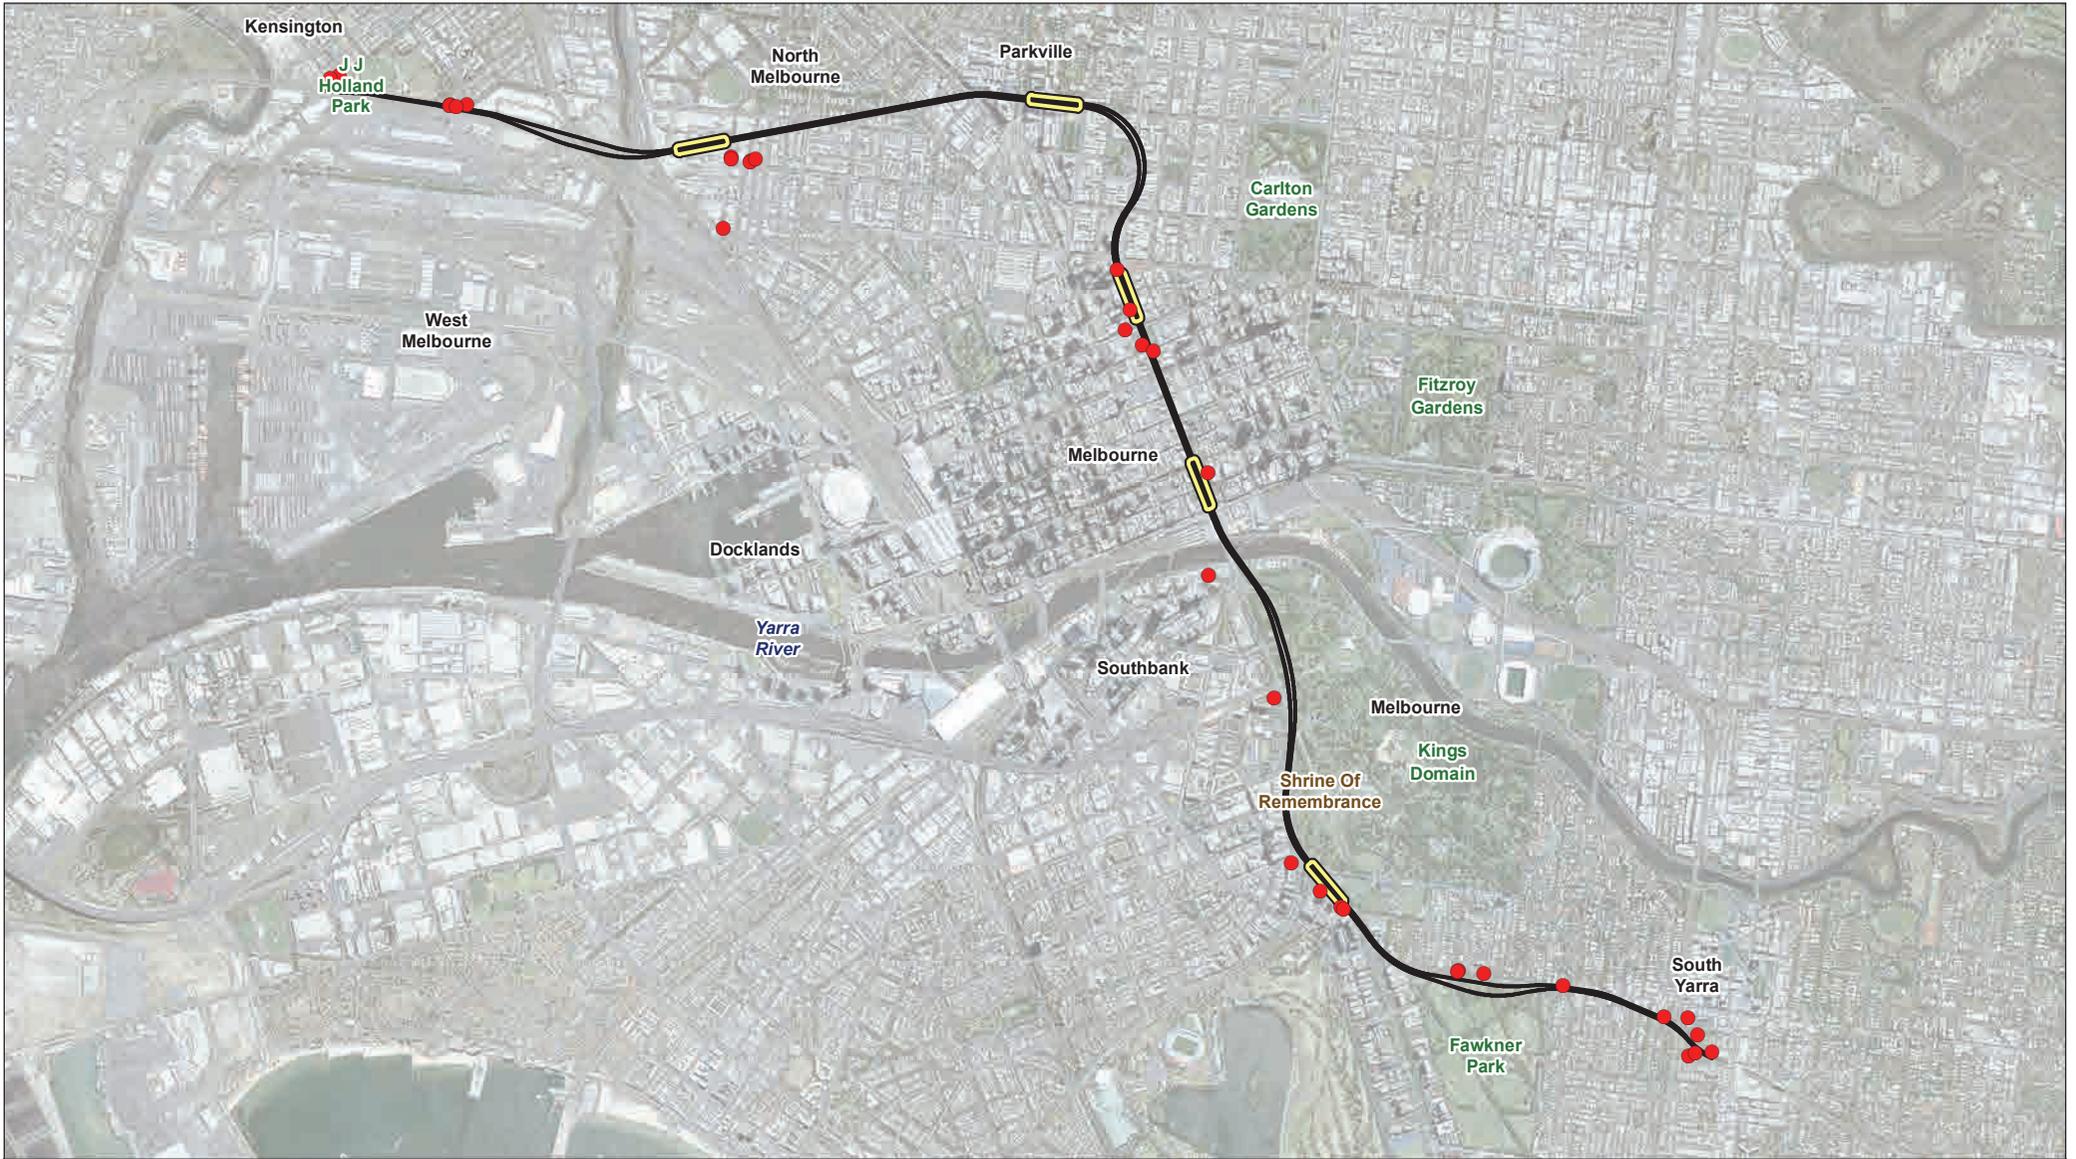
Figure F1: Noise Measurement Locations

Noise Monitoring has been conducted at 22 locations across the Melbourne Metro. The specific locations are detailed in Table F1 and shown in Figure F1.

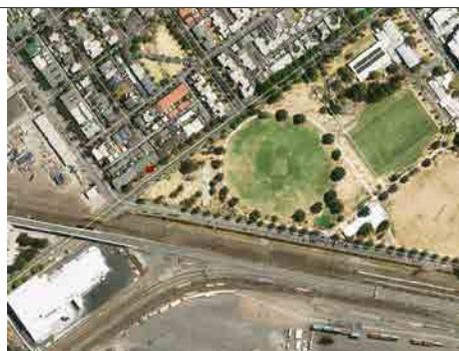
Figure F3: Measurement at Location 2: 138 Kensington Road, Kensington

Image 3: Measurement Location

Parameters:
 LAeq,16hr: 68 dB
 LAeq,8hr: 62 dB
 LAeq, Day*: 67 dB
 LAeq, Evening*: 65 dB
 LAeq, Night*: 61 dB
 LA90 Day*: 54 dB
 LA90, Evening*: 50 dB
 LA90, Night*: 45 dB
 *Adjustment for reflection

Comments: the logger is in the vicinity of the existing railway and was installed at 1 m from the most exposed accessible window.
Measurement location: measurements were conducted in the frontyard.
Meteorology: inclement weather on 3 August and 6 August.
Noise sources: vehicles, pedestrians, trains

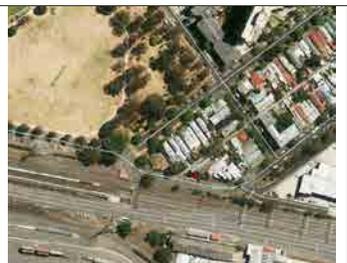
Image 3: Measurement Location

Parameters:
 LAeq,16hr: 69 dB
 LAeq,8hr: 61 dB
 LAeq, Day*: 67 dB
 LAeq, Evening*: 65 dB
 LAeq, Night*: 60 dB
 LA90 Day*: 51 dB
 LA90, Evening*: 46 dB
 LA90, Night*: 46 dB
 *Adjustment for reflection

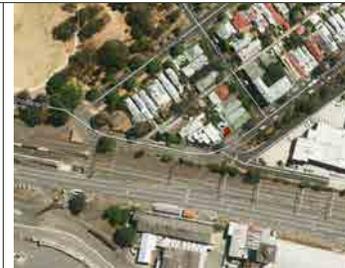
Image 3: Measurement Location

Parameters:
 L_{Aeq,16hr}: 60 dB
 L_{Aeq,8hr}: 54 dB
 L_{Aeq,Day}: 59 dB
 L_{Aeq,Evening*}: 57 dB
 L_{Aeq,Night*}: 53 dB
 L_{A90,Day}: 47 dB
 L_{A90,Evening*}: 43 dB
 L_{A90,Night*}: 43 dB
 *Adjustment for reflection

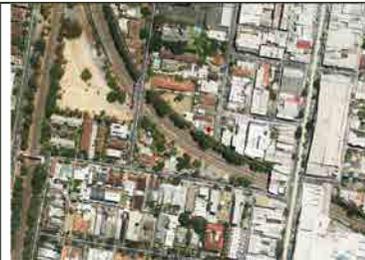
Image 3: Measurement Location

Measurement location: measurements were conducted in the frontyard.

Microphone was approximately 1 m from a reflecting surface.

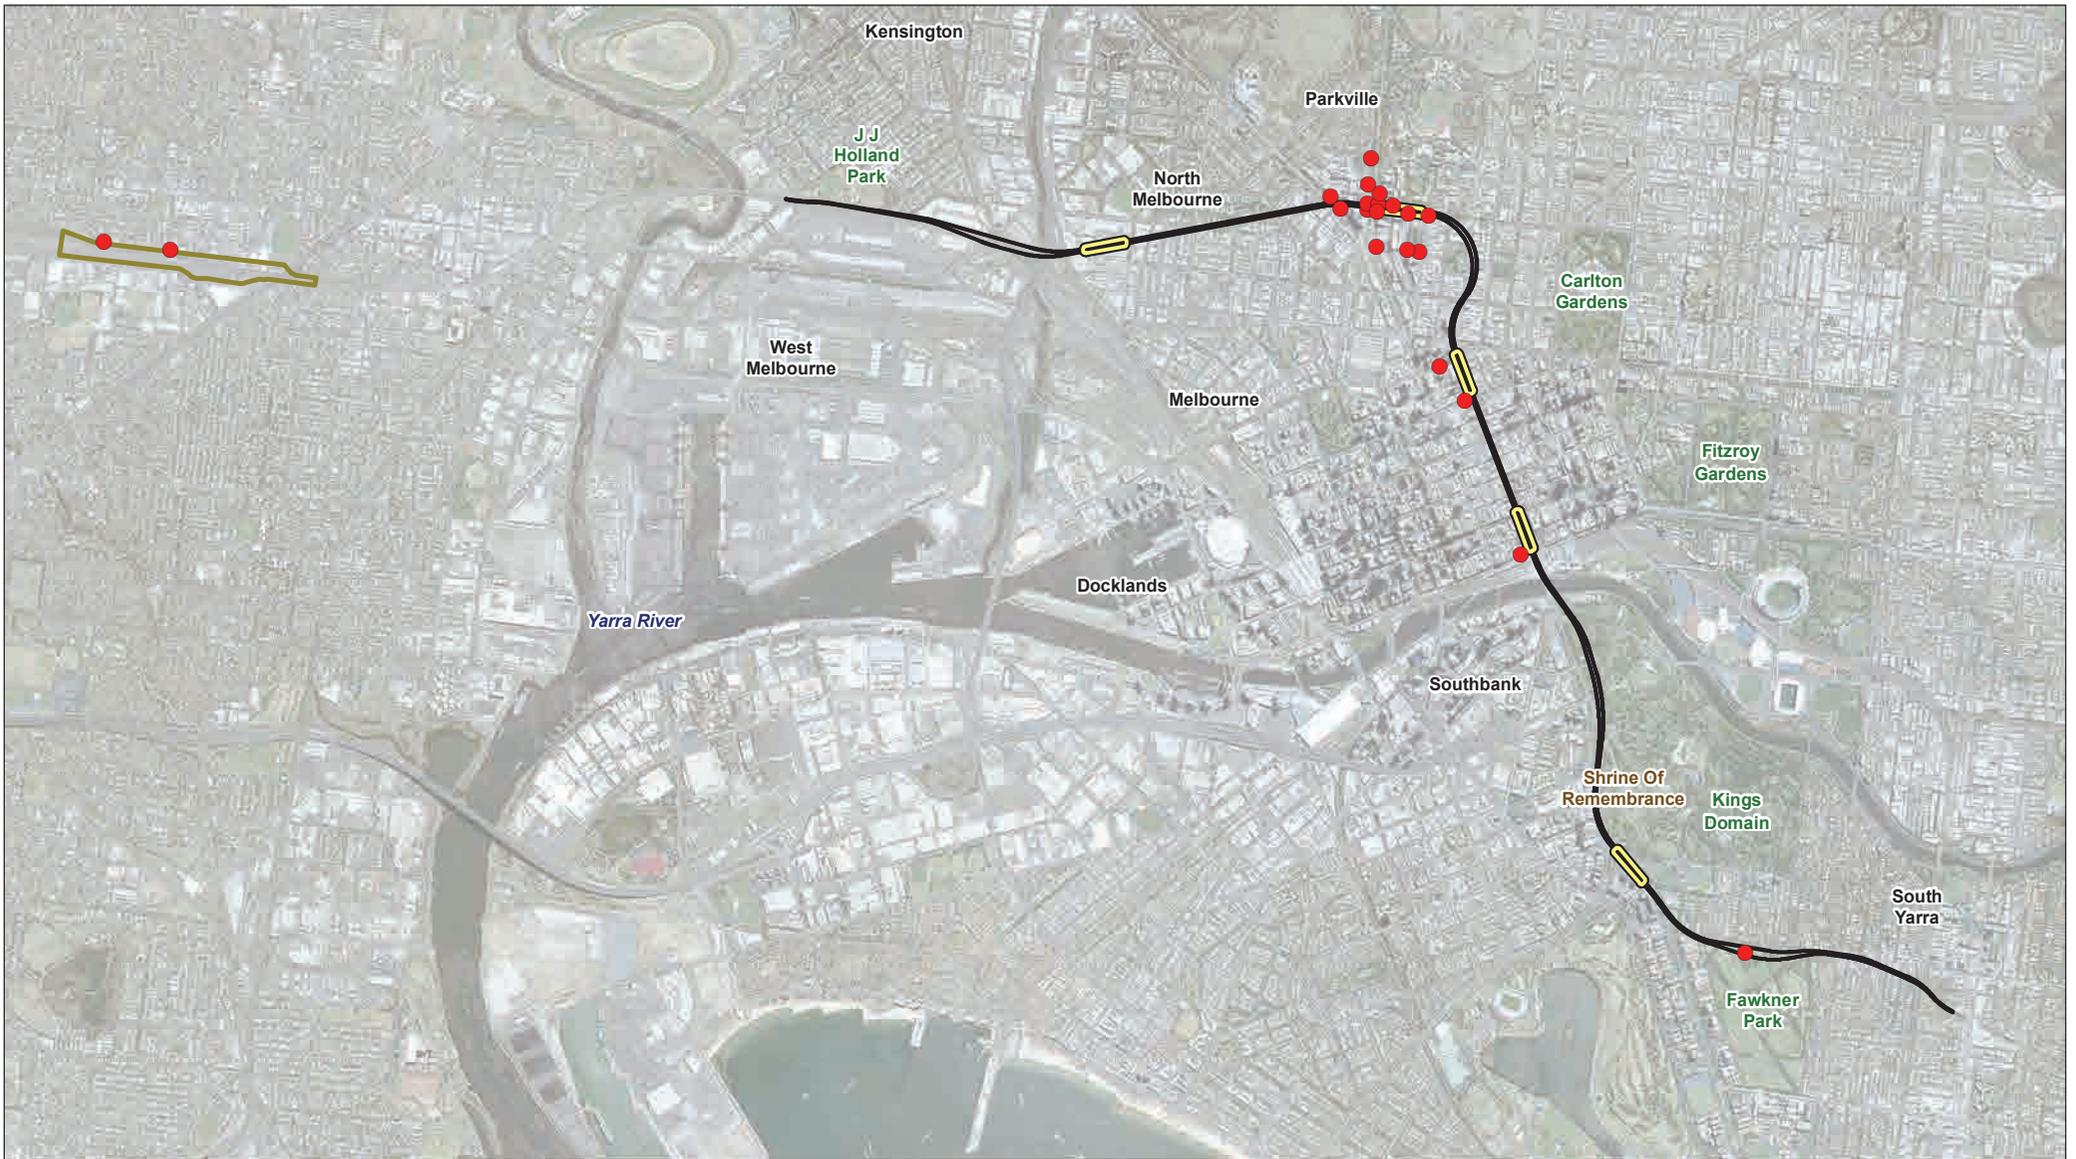
Title:
 Attended Noise Monitoring Locations

Attended External noise measurements have been undertaken in the vicinity of the noise sensitive locations in the Parkville and CBD North and South Area and are provided in Table F3.

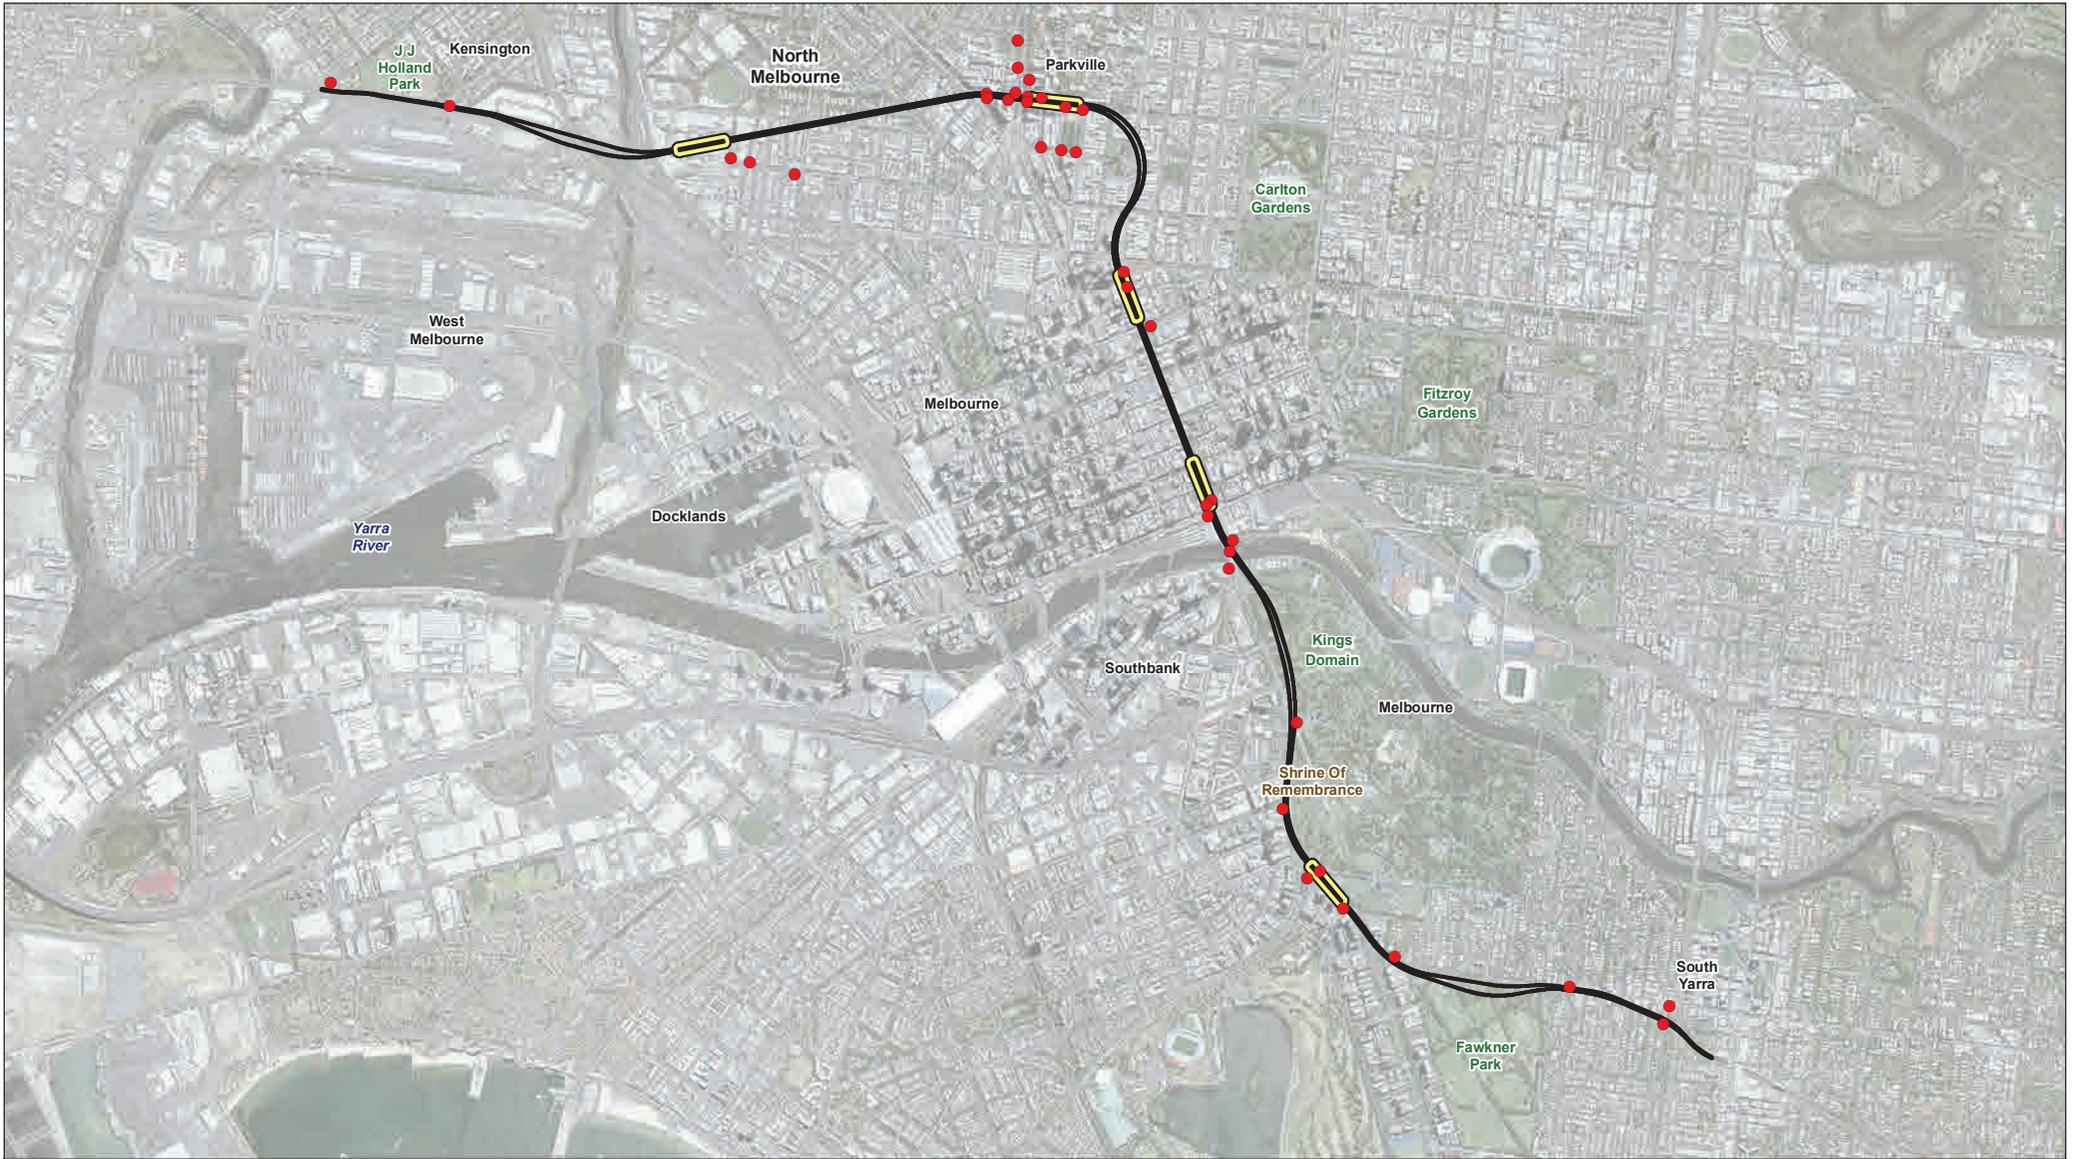
Title:
 Vibration Measurement Locations

Vibration levels have been measured at 40 locations in the vicinity of Melbourne Metro alignment. Details of the vibration locations and a summary of the results is provided in Table F31 and graphs of the results provided in Figure F26 to Figure F65.

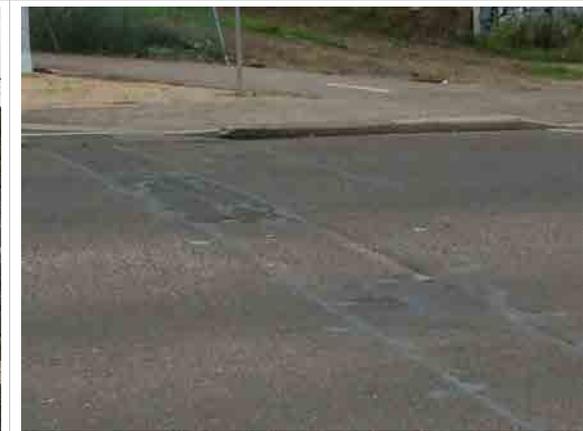
Image 2: Imperfection on Kensington Road

Measurements commenced at 9:02 hours on 30/6/2015. Vibration sources included: cars, buses, trucks, trains, street sweepers, pedestrians. There was an imperfection (image 2) on the road that influenced the data.

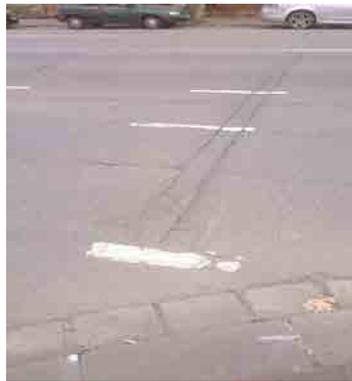
Image 2: Imperfection on Lauren Street

Measurements commenced at 10:09 hours on 30/6/2015. Vibration sources included cars and trucks. There was an imperfection on the road (image 2) that had a significant influence on data.

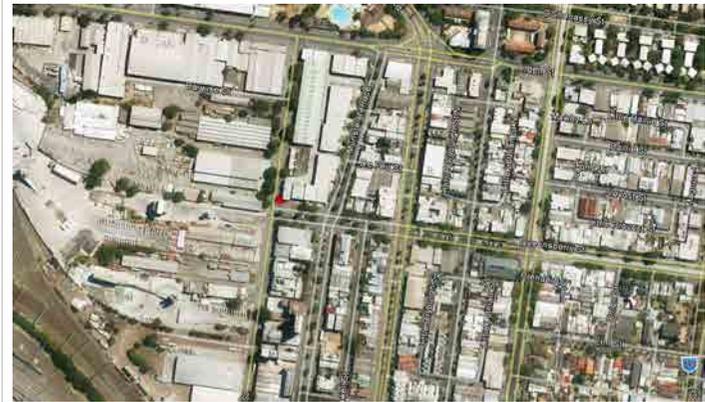
Figure F27: Vibration levels measured at Location 2 - 15 Childers Street, Kensington

Measurements commenced at 9:19 hours on 30/6/2015. Vibration sources included cars, trains, trucks and pedestrians.

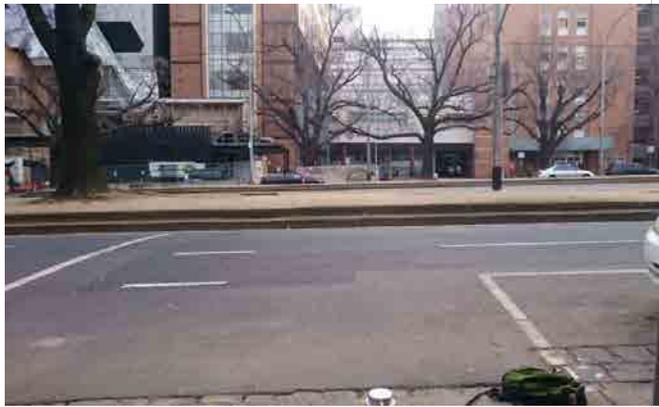
Image 1: Measurement equipment

Measurements commenced at 11:39 hours on 28/7/2015. Vibration sources included cars, trucks, buses and pedestrians.

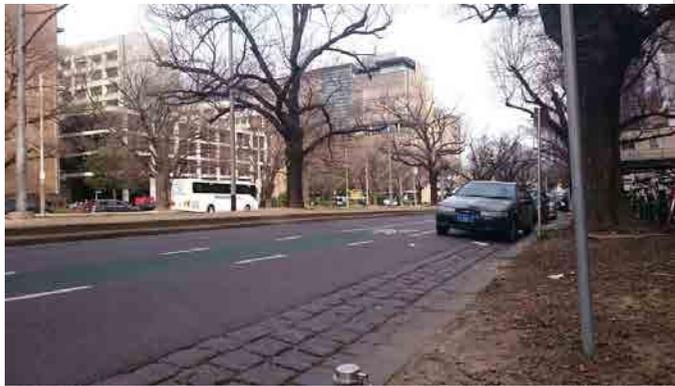
Image 1: Measurement equipment

Measurements commenced at 15:17 hours on 29/7/2015. Vibration sources included cars, trucks, trams and pedestrians.

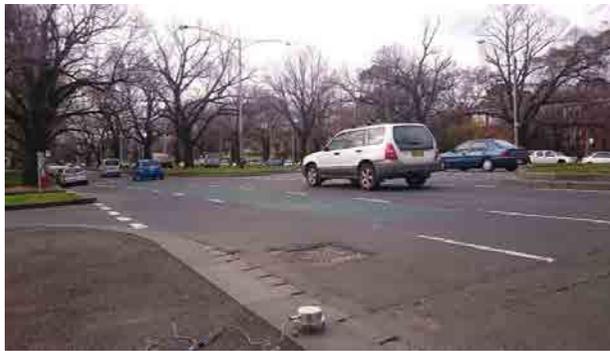
Image 1: Measurement equipment, Royal Parade

Measurements commenced at 14:42 hours on 29/7/2015. Vibration sources included cars, trucks, trams and pedestrians.

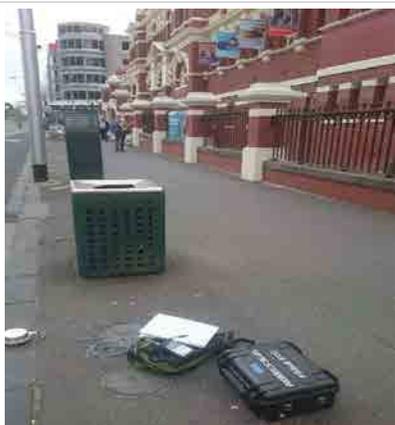
Image 1: Measurement equipment

Measurements commenced at 14:06 hours on 29/7/2015. Vibration sources included cars, trucks, trams and pedestrians.

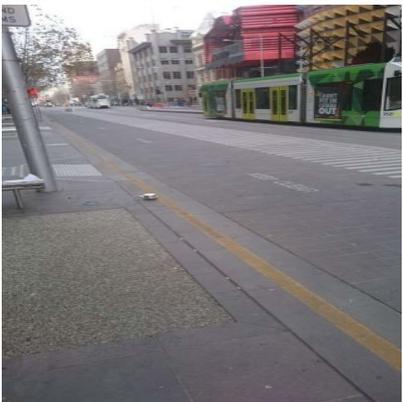
Image 1: Measurement equipment, Swanston Street

Measurements commenced at 9:16 hours on 1/7/2015. Vibration sources included trams, cars, trucks, buses and pedestrians.

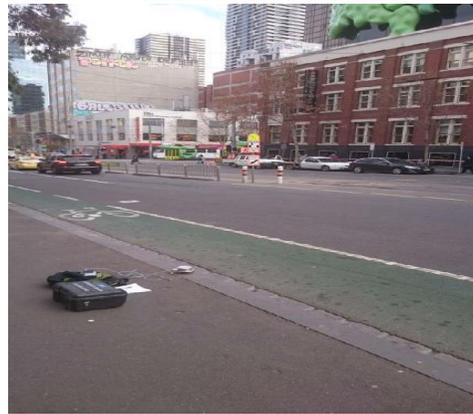
Image 1: Measurement equipment

Measurements commenced at 9:56 hours on 1/7/2015. Vibration sources included trams and pedestrians. High levels of vibration are due to jointed rail tracks.

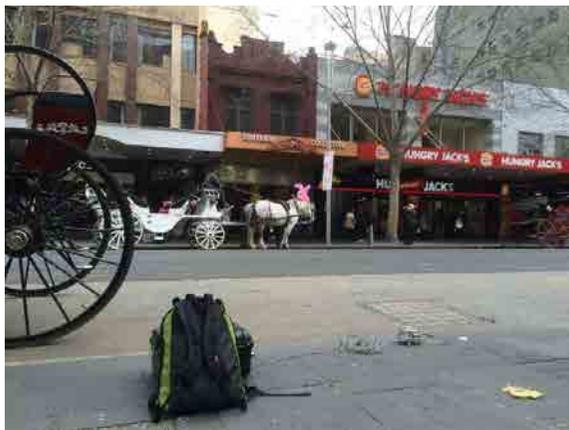
Image 1: Measurement equipment

Measurements commenced at 10:38 hours on 1/7/2015. Vibration sources included trams, cars, trucks, buses and pedestrians. High levels of vibration are due to jointed rail tracks

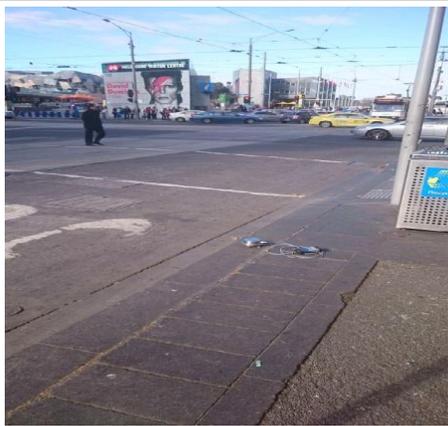
Image 1: Measurement equipment

Measurements commenced at 11:30 hours on 1/7/2015. Vibration sources included trams, cars, trucks, buses and pedestrians. High levels of vibration are due to jointed rail tracks.

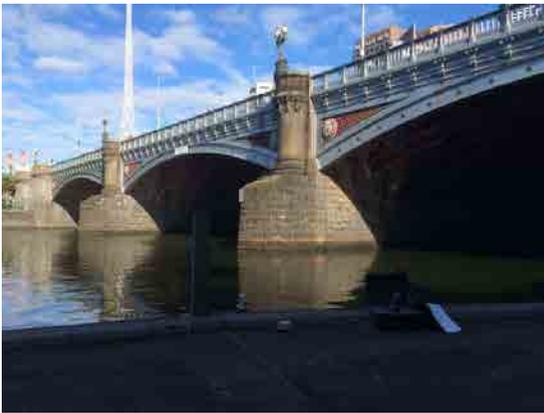
Image 1: Measurement equipment

Measurements commenced at 12:04 hours on 1/7/2015. Vibration sources included trams, cars, trucks, buses and pedestrians.

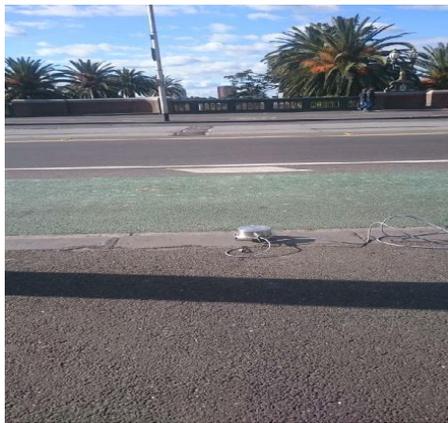
Image 1: Measurement equipment

Measurements commenced at 13:00 hours on 1/7/2015. Vibration sources included cars, trucks, trams, skateboarders and pedestrians. High levels of vibration are due to jointed rail tracks.

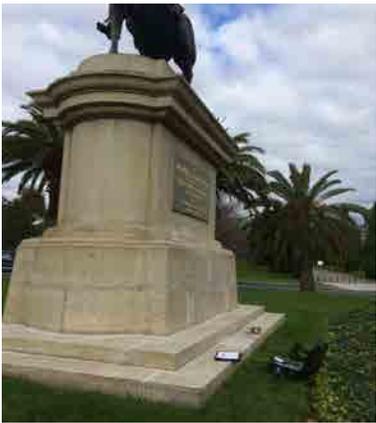
Image 1: Measurement equipment

Measurements commenced at 12:38 hours on 1/7/2015. Vibration sources included cars, trucks, trams, skateboarders and pedestrians.

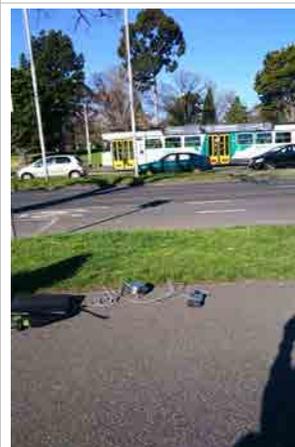
Image 1: Measurement equipment facing St. Kilda Road

Measurements commenced at 14:04 hours on 1/7/2015. Vibration sources included cars, trucks, buses and trams.

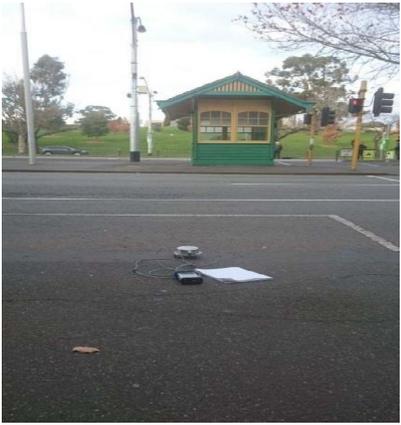
Image 1: Measurement equipment

Measurements commenced at 15:21 hours on 10/9/2015. Vibration sources included cars, trucks, trams and pedestrians.

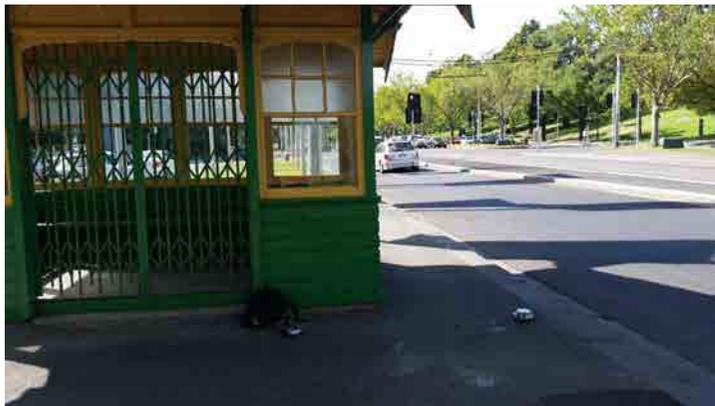
Image 1: Measurement equipment

Measurements commenced at 15:39 hours on 1/7/2015. Vibration sources included cars, trucks, trams and pedestrians.

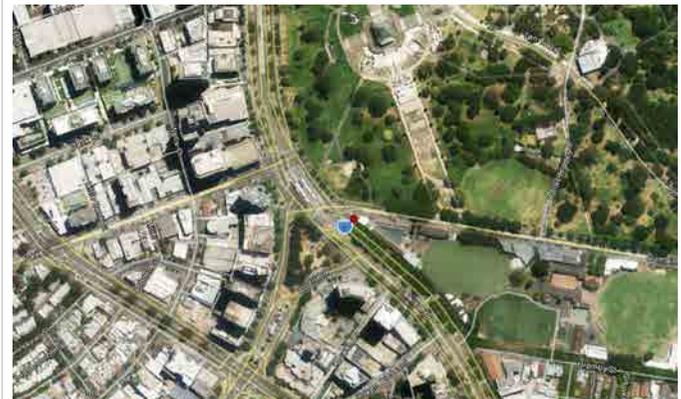
Figure F60: Vibration levels measured at Location 35: 321 St. Kilda Road, Melbourne

Measurements commenced at 15:00 hours on 1/7/2015. Vibration sources included cars, trucks, trams and pedestrians.

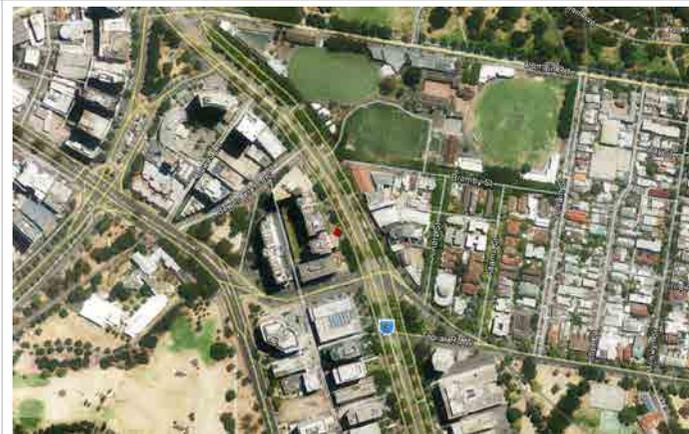
Figure F61: Vibration levels measured at Location 36: 402 St. Kilda Road, Melbourne

Measurements commenced at 14:59 hours on 1/7/2015. Vibration sources included cars, trucks, trams and pedestrians.

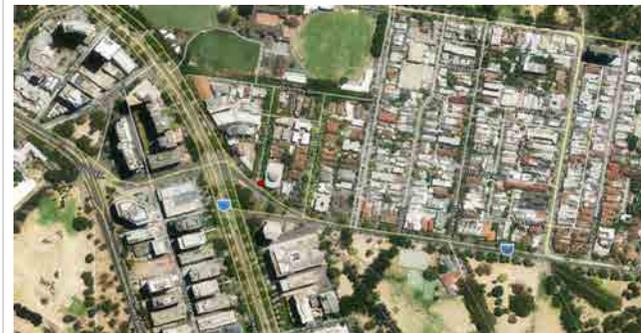
Figure F62: Vibration levels measured at Location 37: Melbourne Hebrew Congregation, South Yarra

Measurements commenced at 12:05 hours on 18/9/2015. Vibration sources included cars, trucks and pedestrians.

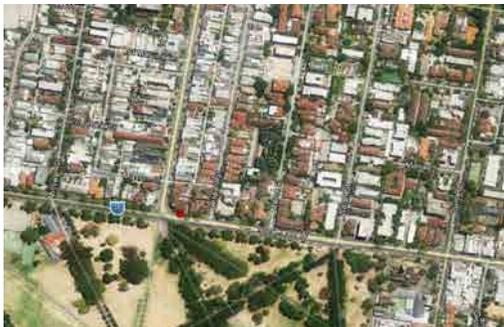
Figure F63: Vibration levels measured at Location 38: 2 Park Street, South Yarra

Measurements commenced at 11:27 hours on 18/9/2015. Vibration sources included cars, trucks, trams and pedestrians.

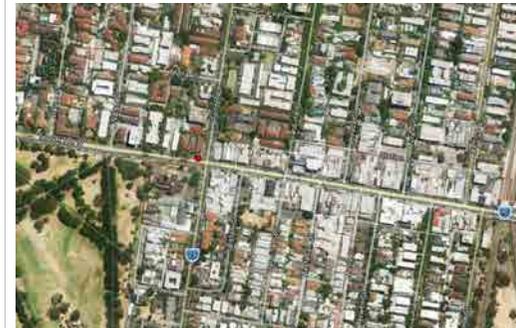
Figure F64: Vibration levels measured at Location 39: 186 Toorak Road W, South Yarra

Measurements commenced at 10:50 hours on 18/9/2015. Vibration sources included cars, trucks, trams and pedestrians.

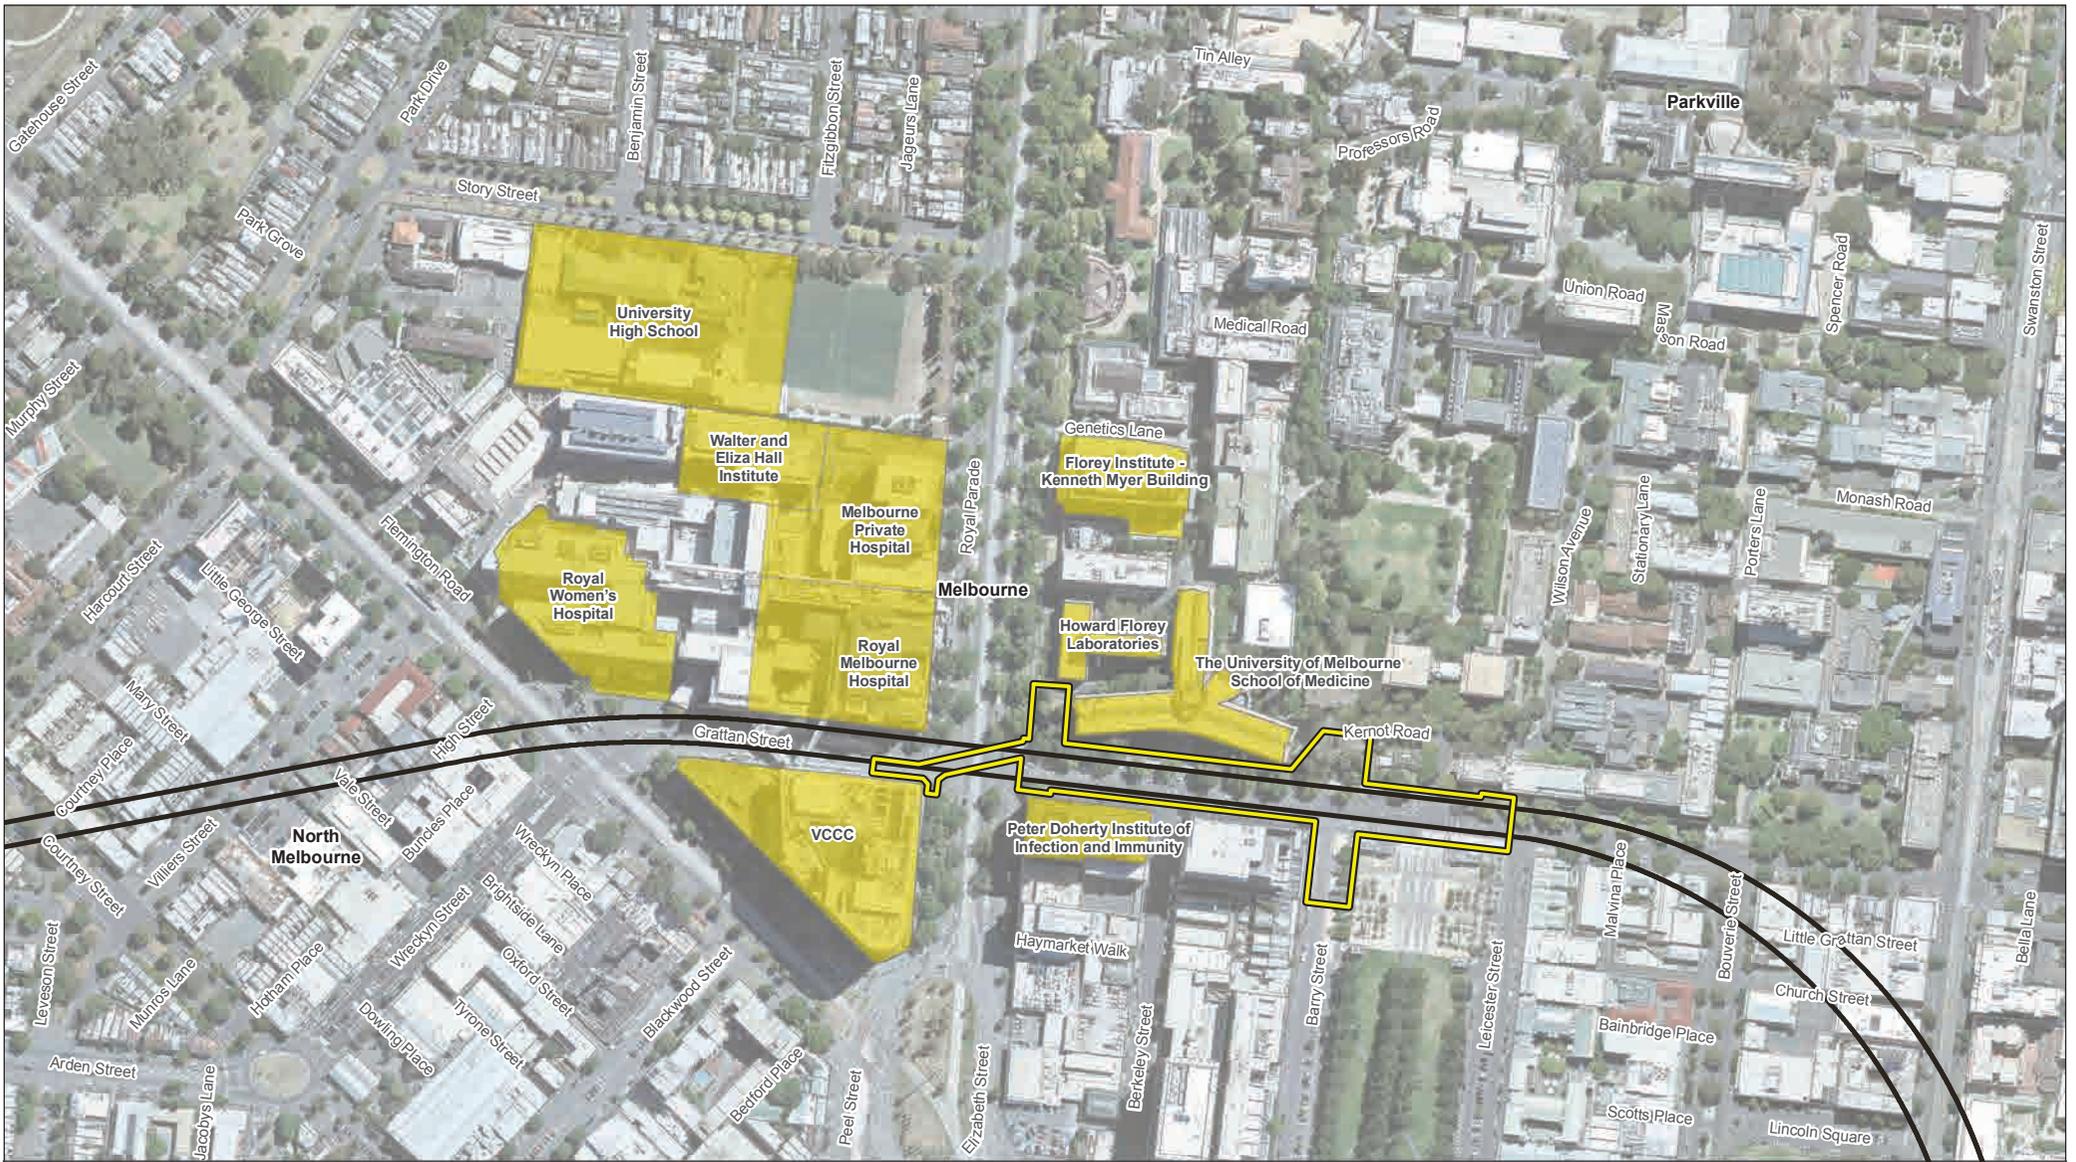
Title: Parkville Hospital Measurements

Vibration sensitive equipment has been identified at all locations presented in Table F32. Strategic locations have been identified for vibration measurements and these locations are provided in Section F.5.3.
